## **SURFACE DAMAGES CAUSED BY CAVITATIONS AT HOOD OF HOWELL BUNGER VALVE AND REDESIGN TO AVOID THEM**

### **ABSTRACT**

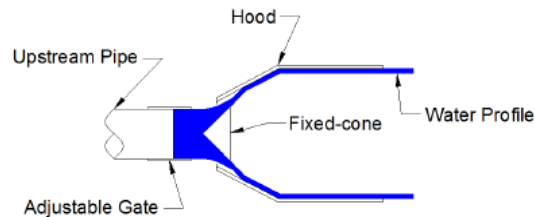
**Figure 1: Fixed Cone Dispersion Valve (FCDV) with Discharge Hood [2]**

- A stationary hood can be placed over the conical jet as shown in Figure 1.
- Presence of a steel hood connected (installed) at the sliding part of the valve as shown in Figure 3. that effectively reduces the spray formation and limits lateral jet spreading within acceptable limits (Ring valve).

The ring jet valve is endowed with a steel hood, which confines the lateral spreading of the air-water mixture. The inward deflection of jet streamlines enhances momentum exchange and gives rise to a contracted section observed at a distance of approximately 3 to 4 times the hood diameter. Beside these aspects, swirling motion has also been observed at the outlet.

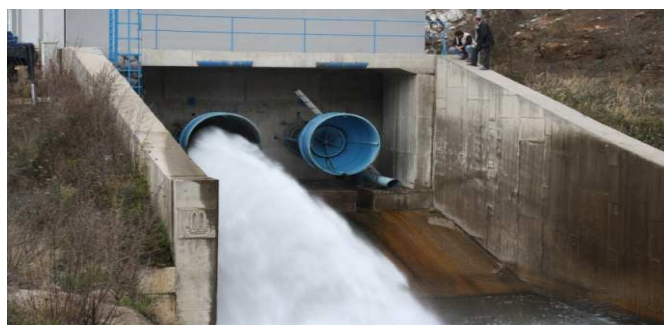
**Figure 2: Site Conditions**

Dam Lisiche - Veles, belongs to the system for the supply of drinking water (pipeline for cold water) and water for irrigation (pipeline for warm water). Both pipelines are used for bottom discharge of the lake. These two pipelines are installed along with the Howell Bunger valve to drain the water in riverbed Topolka. Technical characteristics of the dam are:

- maximum elevation: 452.12msl
- nominal elevation of water: 423 msl
- axis elevation of valve: 359.08 msl

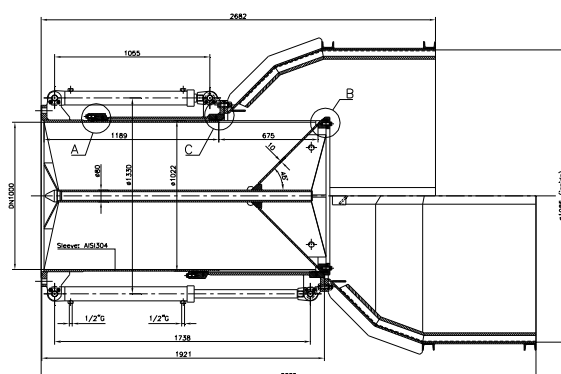
**Figure 3: Longitudinal Section of Valve with Sliding Hood**

Construction of Howell Bunger valve consists of a cylindrical sliding segment, which is the carrier of the sealing flange A and C and the hood, and the static part of the valve which consists of a centrally placed tube. The movement of

valve (open/close) is achieved by hydraulic cylinder. In inner space of hood, are installed four cross-contrary aeration pipes.

- maximum flow: 12.79 m<sup>3</sup>/s
- nominal flow: 2.04 m<sup>3</sup>/s
- nominal diameter of 1000 mm
- valve stroke: 675 mm
- nominal pressure: 10 bar
- operating pressure: 6.6 bar
- testing pressure: 13,3 bar

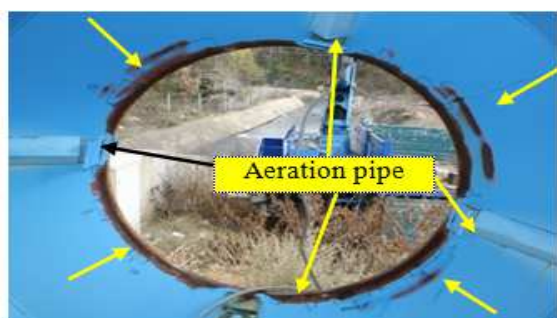
**Figure 4: Zone of Cavitations Damages**

In the first year of exploitation, the need of continuous discharge of water through both valves (exploitation condition) was with flow rates of 0.5 to 3 m<sup>3</sup>/s (an average discharge of water is about 0.8 m<sup>3</sup>/s per valve). This means that the valve is open approximately 12-15 mm. After one year exploitation period, due to these exploitation conditions, significant surface damages caused by cavitations were detected on the hood. The main damages are located in the zone between aeration pipes fig.4. The cavitation damages occurred symmetrically around the surface between hood flange and hood cone.

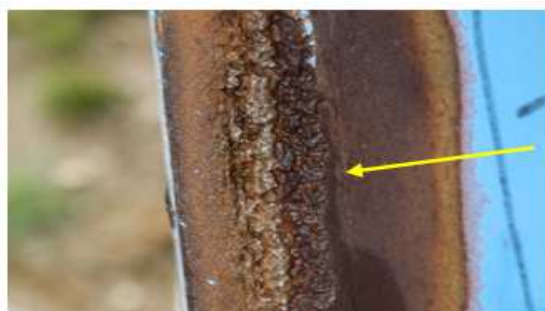
**Figure 5: Zone of Cavitations Surface Damages**

In this case, intensive cavitations process mainly occurred in the welded zone and the weld surroundings. Figure 5 thru Figure 7 shows zones affected by cavitations' surface damages process. Serious surface cavitation effects are shown on Figure 6 and Figure 7.

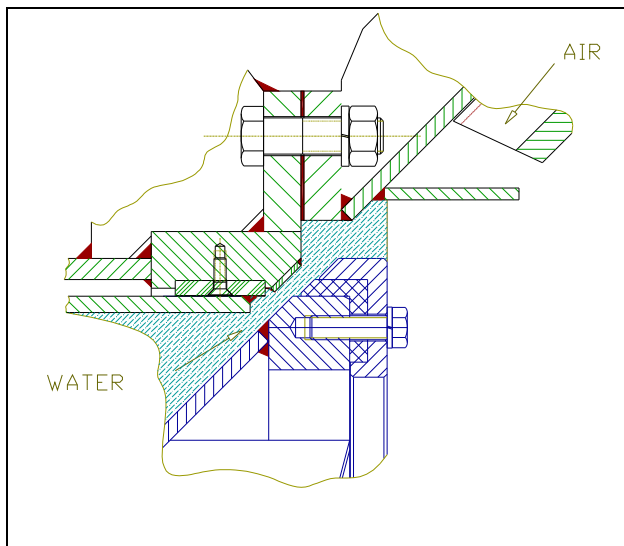
**Figure 8: Flow Domains in Low-opening of Valve**

The analyses of the flow domain in position of the small opening of the valve show that there are sections between hood and valve cone where flow velocity increases and the velocity decreases in the closed space which is not properly aerated (Fig.8). This configuration of flow domain is basic for potential obtaining cavitations phenomena. The cavitations damages which occurred at the valve hood confirm the same zone.

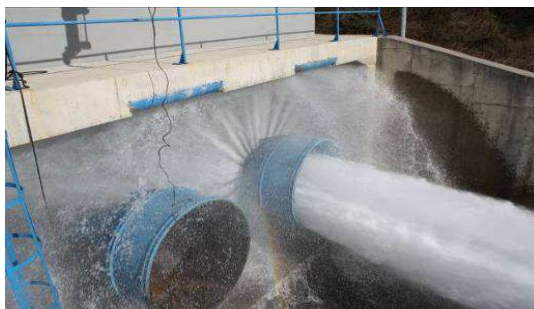
Figure 11: Effect of Back Splash at Redesigned Hood

- The numerically predicted effect of back splash was tested at site. The hood was installed with no changed of all its constructive elements. This case position is done only for confirmation of numerical prediction of back splash, and the effect of back splash was happening, Figure 11. The main reason for back splash was obstacle of elements of the basic aeration system of the hood which cannot obtain a free stream fluid flow.

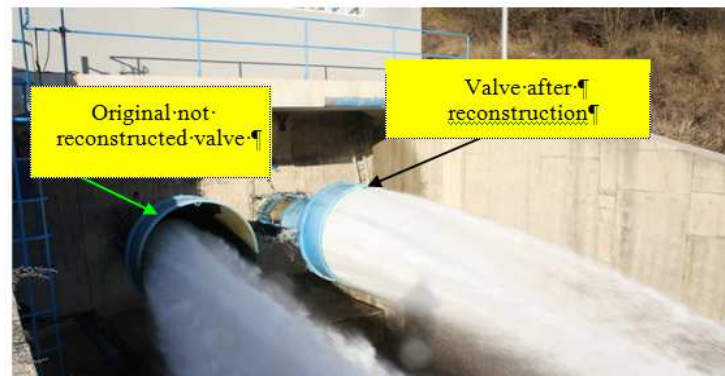
Figure 13: Redesigned Hood and Outlet Water Jet

- The influence of redesigned hood on dispersion of the outlet water jet was comparatively tested in case for obtaining the same openings - discharge (approximately  $0,5 \text{ m}^3/\text{s}$  or 10 mm opening) at reconstructed and basic design of the valve, Figure 13. For small openings of the valve the reconstructed hood has a uniformed outlet jet form and dissipation of energy is better than the basic model of the valve.

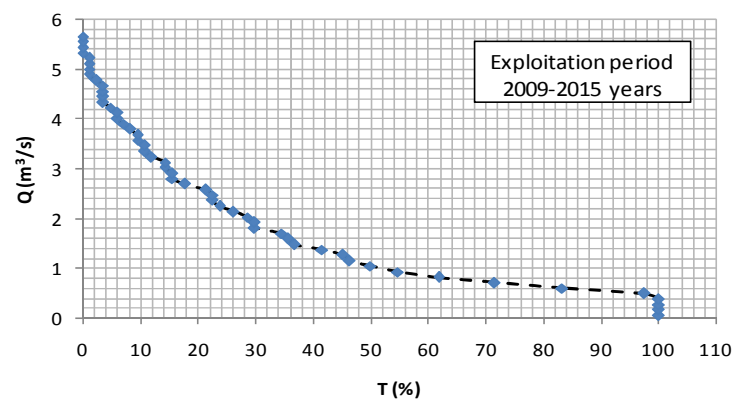
Figure 14: Flow Duration Curve for Exploitation Period of Seven Years

The reconstruction of redesigned valve was established in 2009 year. Working conditions of the redesigned valves after seven years (2009-2015) of exploitation period are represented through the discharge curve given on Figure 14.

On the base of the flow duration curve can be seen that ~50% of exploitation conditions of the valve was happening for small openings of the valve. This means that main operating position of the valve is with a small opening section.

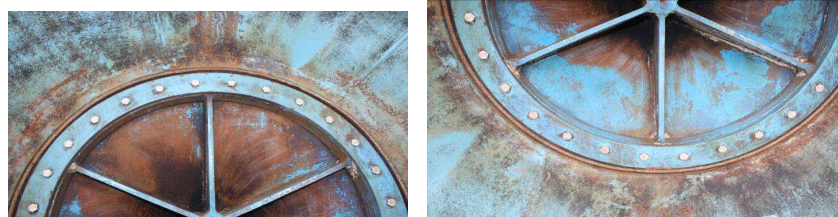
**Figure 14: Surface of Hood in Closed Position (Front View)**

Visual control revealed another type of damage compared to the damage caused by the cavitation found in 2009. The new surface conditions are shown on the Figure 14 thru Figure 17.

- After seven years of exploitation, no surface damage of the type of cavitation was detected.
- Certain surfaces are affected by corrosion, which is a normal occurrence for such equipment.
- The surfaces of the valve cone are affected by corrosion at the zone in front of the sealing ring.
- To deal with the occurrence of corrosion, an occasional recovery of anticorrosion protection, especially on surfaces near the sealing rubber ring, is required.
- No surface damage was detected on the inserted ring.
- The work of the redesigned hood is stable and no interference in the functionality of the valve has been observed.
- During the seven-year exploitation there was no need for repairs or servicing.
- This is sufficient proof that with the redesign and reconstruction of the bonnet the target has been achieved, ie the emergence of cavitation has been eliminated.
